FAILURE ANALYSIS

# Microbiologically Influenced Corrosion in a Copper Tube Chiller

ALBERT OLSZEWSKI, *Constellation Energy, Baltimore, Maryland*

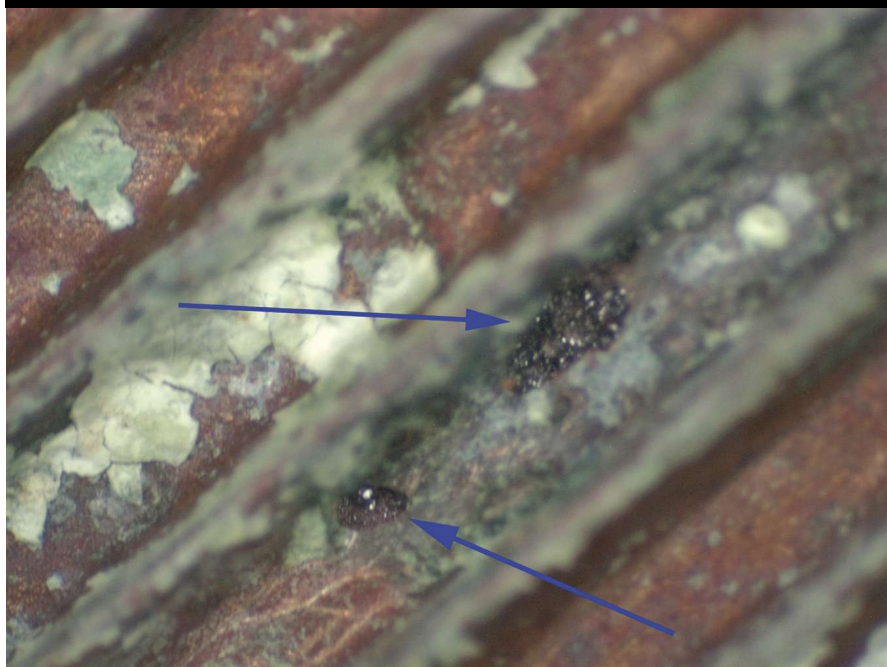
FIGURE 1

Green-colored deposits and scaling were readily apparent throughout the waterside (inside) of the tube. Beneath the deposits, areas of localized corrosion were apparent (Figure 1). Metallographic mounts, prepared at the corrosion sites, revealed a perforation at one location and severe corrosion of an internal riffling at another location (Figures 2 and 3).

Pitting beneath internal diameter (ID) deposits, 30X original magnification.

The copper tubes contained numerous sites of localized corrosion (pitting). The pits were covered by tightly adhered deposits, which were rich in phosphorus. It has been reported that phosphorus-rich deposits might indicate bacterial activity, as bacteria use phosphorous chemistry in their energy processes.<sup>1</sup>

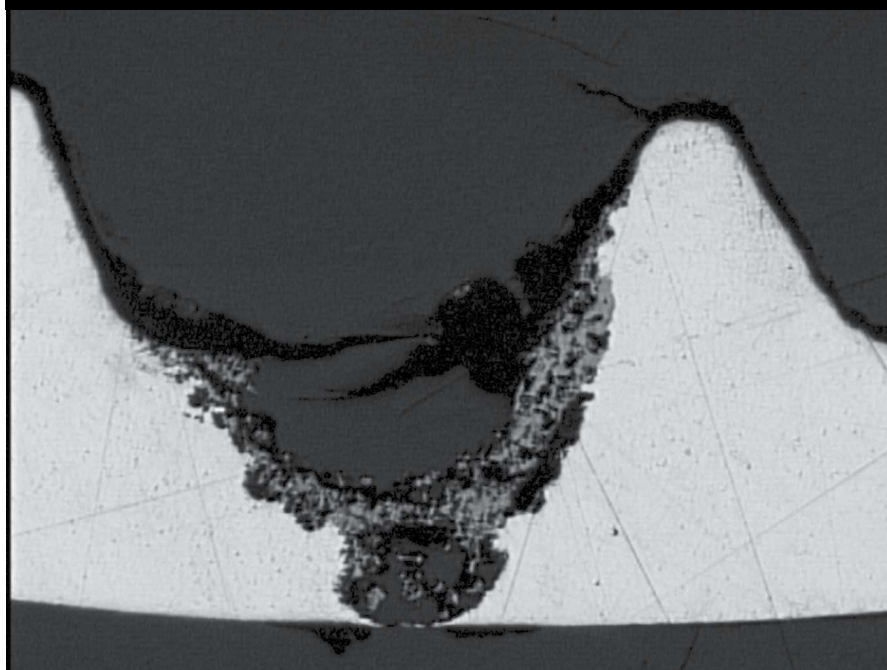
FIGURE 2

Tube perforation, 63X original magnification.

The poor water treatment program created conditions conducive to MIC. In select locations, the growth of bacteria most likely caused the corrosion of the copper tubes until a perforation occurred.

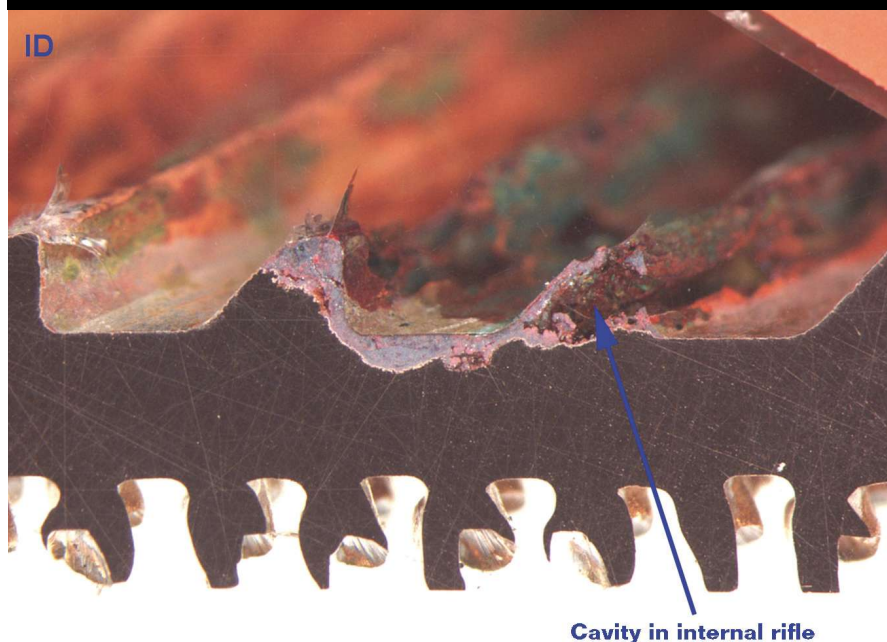
FIGURE 3

ID corrosion of internal fin, 25X original magnification.
