## *Materials Performance Anchor Rod Questions and Responses*

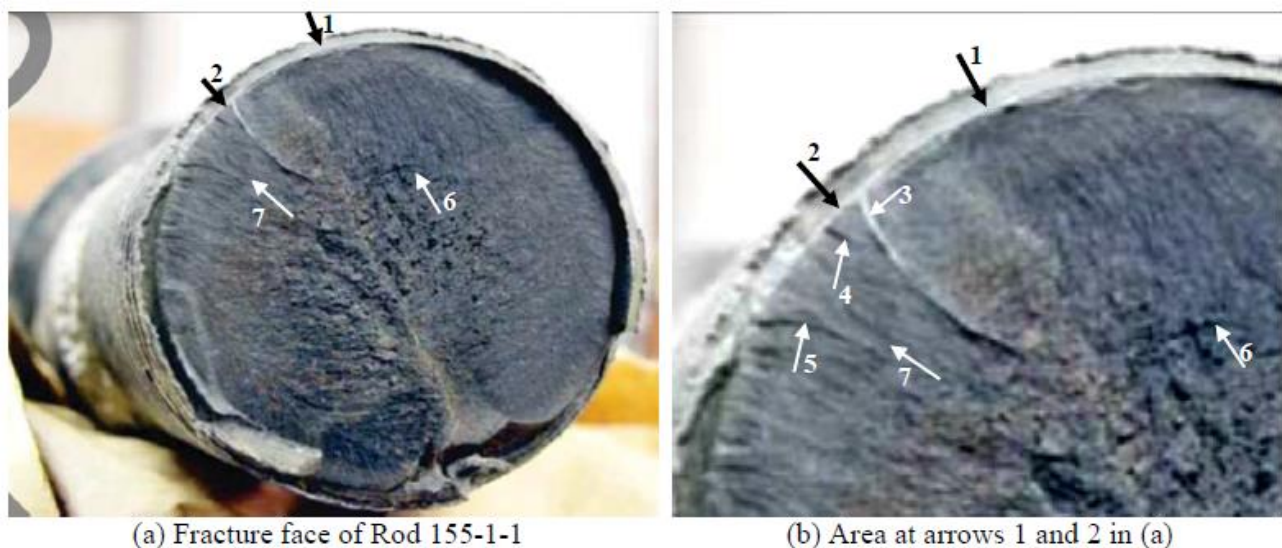
Figure 4a shows the fracture face of this rod.<sup>30</sup> It shows that Rod 155-1-1 failed in a macroscopically brittle manner with the fracture face perpendicular to the rod axis. Only two failure mechanisms can account for this type of failure at room temperature: fatigue cracking and EHE. Since the tower base anchor rods are not subjected to cyclic stresses higher than the pretension levels (0.48Fu in this case), EHE is the only plausible failure mechanism to account for this brittle failure, irrespective of the fracture mode, intergranular cracking (IGC) vs cleavage.

Figure 4 (a) The fracture face of rod 155-1-1. Arrows 1 and 2 mark two of numerous EHE fracture initiation sites. (b) Enlarged view of the EHE initiation sites in (a). Arrows 3 - 5 point to three of numerous ratchet marks and arrows 6 and 7 to possible demarcation lines of EHE/overload.

The fracture face in Figure 4a displays numerous crack initiation sites. Arrows 1 and 2 point to two of them. Arrows 3, 4, and 5 in Figure 4b point to three of the numerous ratchet marks. They are the ridges formed between neighboring fracture propagation zones, each with a separate crack initiation site. The ratchet marks typically occur in high cycle fatigue cracking, EHE cracking, and SCC.

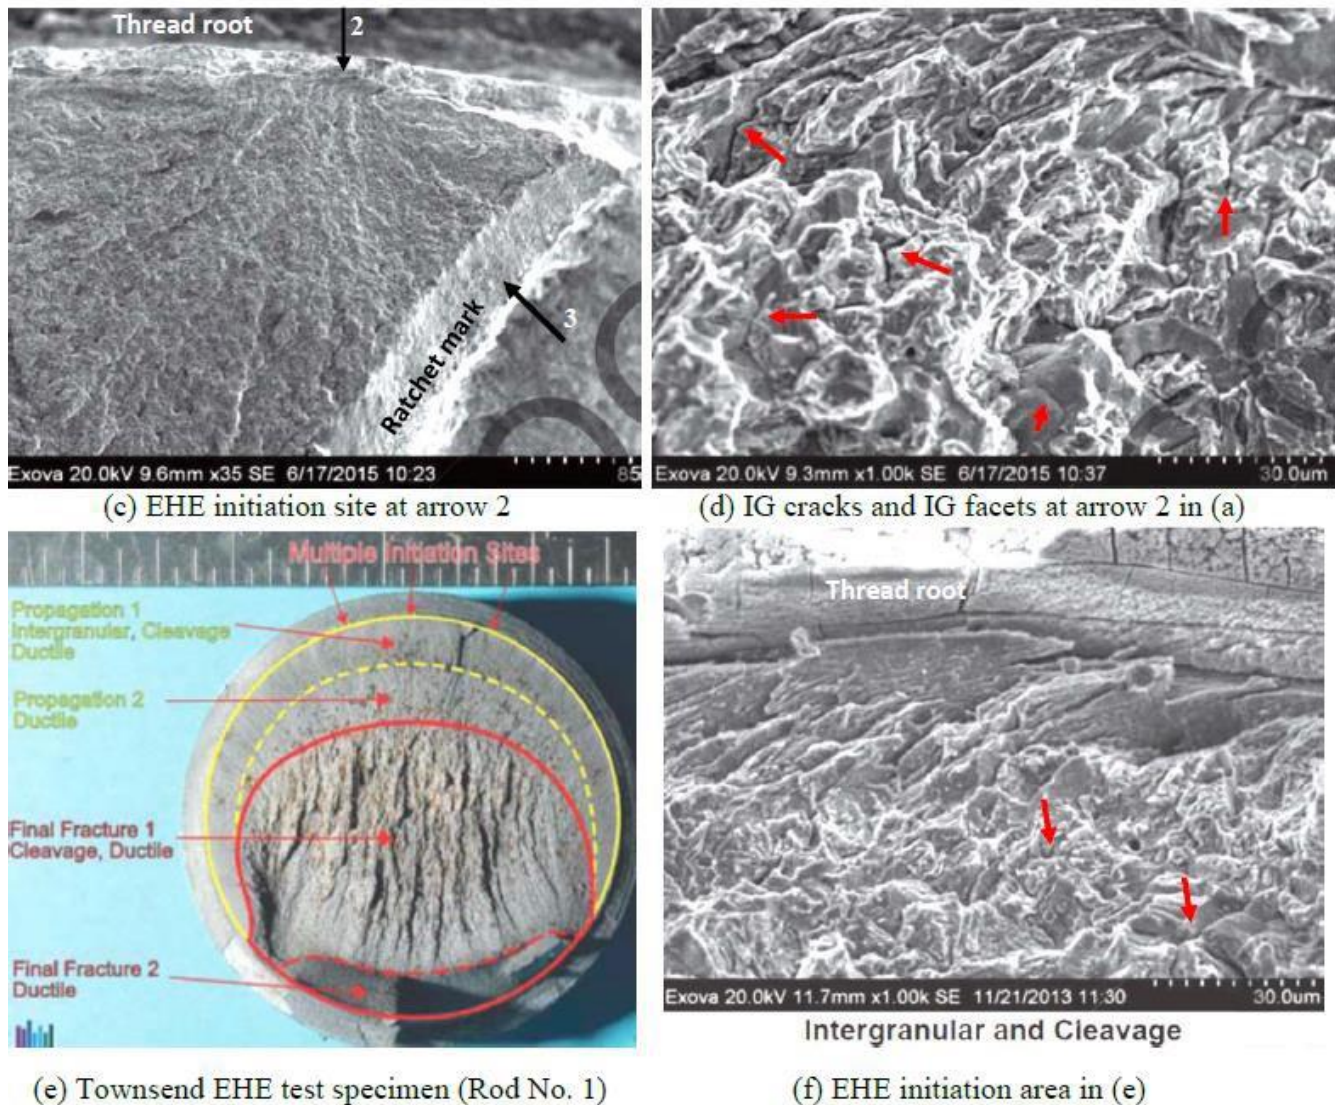
Figure 4 (c) Scanning electron fractograph of the EHE initiation site at arrow 2. (d) Intergranular cracks and intergranular facets at the arrows in the EHE initiation site in (c). (e) The fracture face of a Townsend EHE test specimen (Rod No. 1 – B1F4). (f) A scanning electron fractograph from the EHE initiation site in (e) that is identified as “intergranular and cleavage” by Exova.

Figures 4c and 4d show IGC and IG facets in the fracture initiation site at arrow 2.<sup>31</sup> These IG indications in the failed tower rod may be compared with those of a Townsend EHE test specimen, shown in Figures 4e and 4f.<sup>32</sup> Exova labeled Figure 4f “Intergranular and Cleavage.” By comparison, however, Figure 4d has more IG indications than Figure 4f. Exova interpreted Figure 4d as

The ratchet marks and the IG cracks in Figure 4d are common fracture markings that are consistent with EHE. The same features were found also in the Exova’s fractographs at arrow 1 in Figure 4b. The following statement is attributed to the Exova metallurgical engineer who interpreted the fractographs:

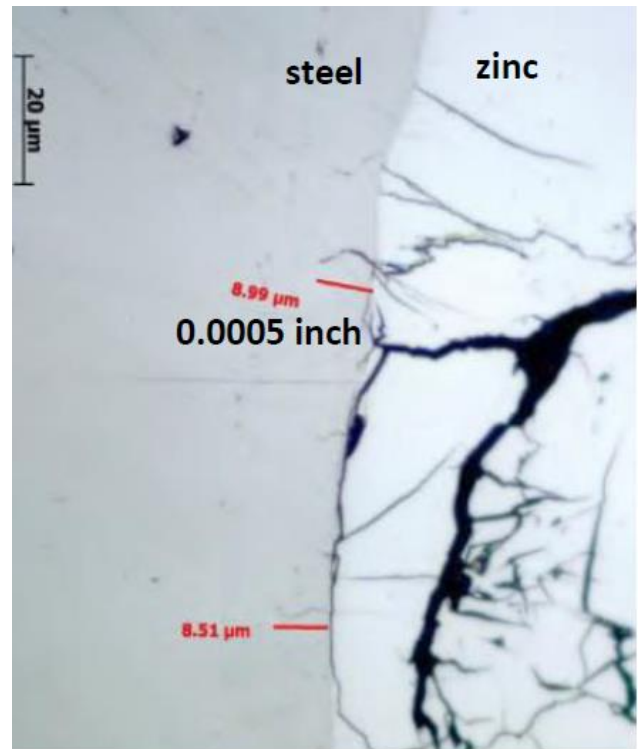
Fig. 5 Micrograph of a thread root, showing numerous cracks in the zinc coating.

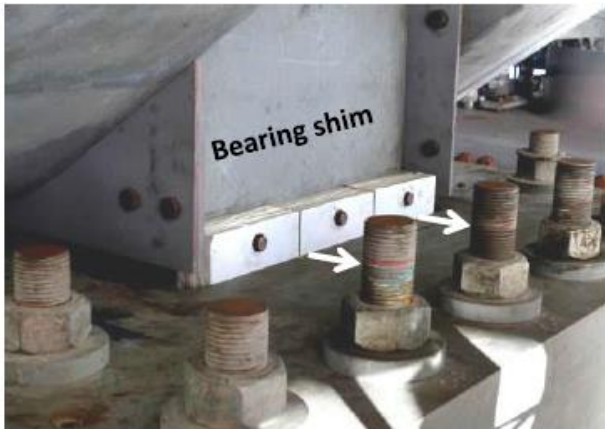
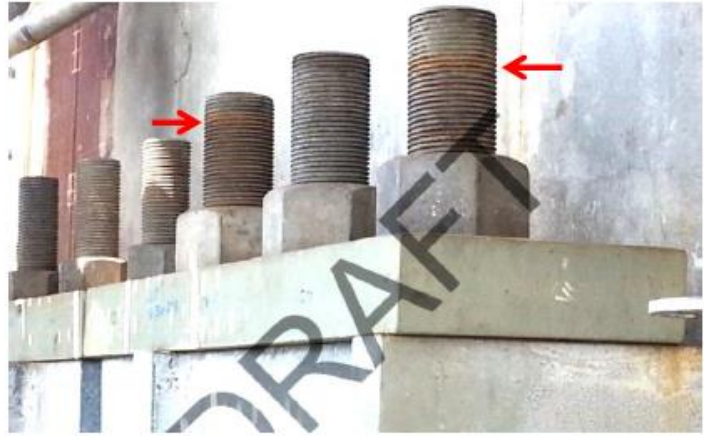
(a) Bearing base plate 3 in dia BD rods

(b) Tower base 3 and 4 in dia BD rods

Fig. 7 BD anchor rods with white and red rusts, marked by the arrows, in the threads in 4 to 5 years of exposure to the San Francisco Bay marine atmosphere.

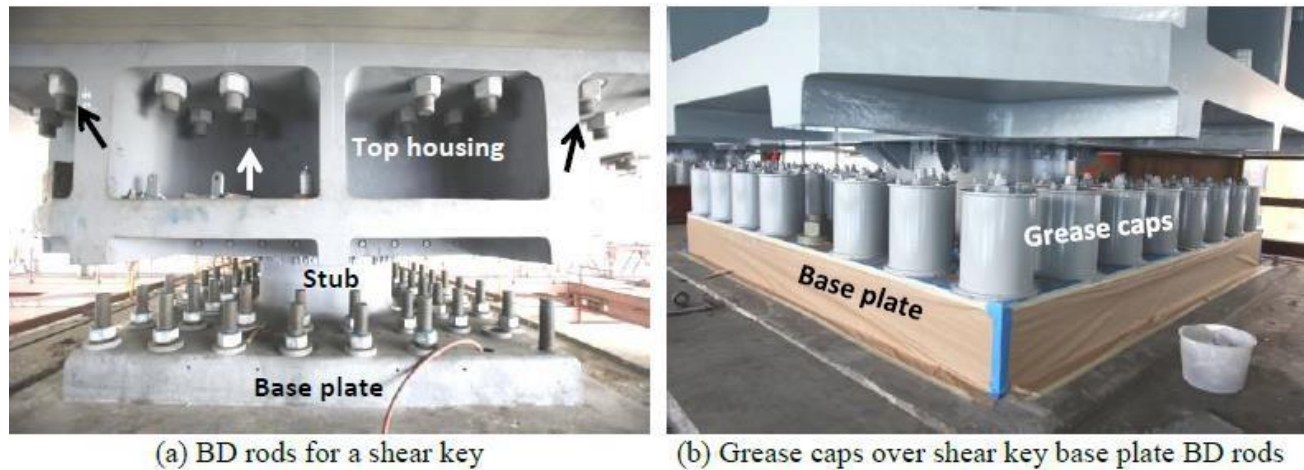
Fig. 8 BD rods for a shear key before and after application of grease caps.

According to Reference 26, the grease caps/paint were to be applied also to the BD rods for the shear key/bearing top housings. The arrows in Figure 8a point to some of the many BD rods that are not amenable for grease cap installations or surface preparation/painting because of lack of flat bases or limited accessibility. These rods for the upper housings of shear keys and bearings on Pier E2 are not difficult to replace. The BD rods with high hardness (e.g., >36 HRC) could be replaced with new HDG BD rods that are resistant to EHE failures. This approach could be more cost effective than installing and maintaining grease caps or painting.

leaking. These grease caps shall be repaired and sealed to eliminate leakage.”<sup>50</sup> Figure 8 provides an example of grease caps applied to the base plate of a shear key.

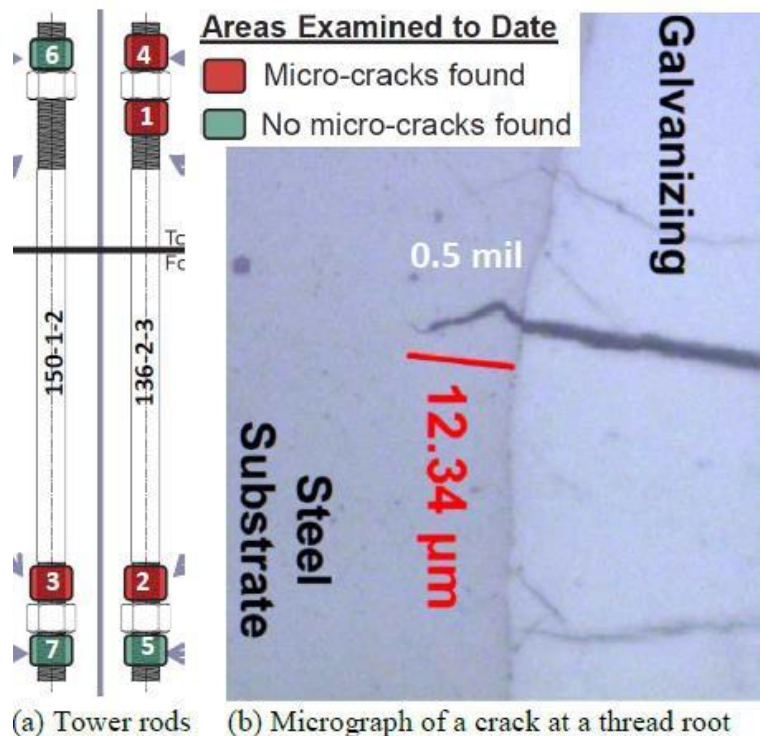
Fig. 9 An example of a microscopic crack in tower BD rods.

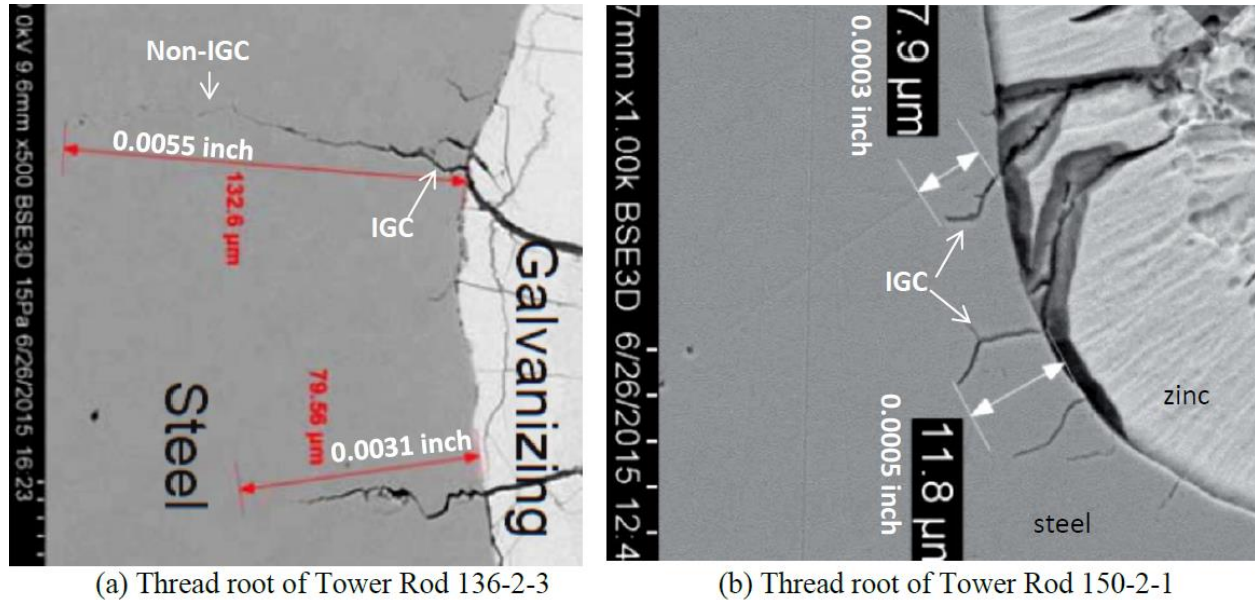
**A7** More details than those reported by Caltrans are needed to assess the significance of the microscopic cracks found in the thread roots of the two tower base BD rods, 136-2-3 and 150-1-2 (Figures 5, 9, and 10).<sup>54</sup> The microscopic cracks in Figure 10 include those that display IG indications, which lined up with cracks in the zinc coating. They clearly did not result from thread cutting or thread rolling.

Figure 10 Microscopic cracks with IG and non-IG indications in the tower rod thread roots.

These cracks, about 0.0055 in or less deep in the steel, were first found (inadvertently) while checking the zinc coating thickness under a microscope. If microscopic cracks are found consistently in the thread roots that experienced even transient loading, it would be significant because it could affect the understanding of EHE failures of HDG BD rods. This is particularly so because most of the microscopic cracks in the steel have lined up with cracks in the zinc coating and some in the steel are decidedly intergranular, at least in the initiation stage. Without a complete stress hysteresis of the specimens, it would be impractical to estimate their significance.

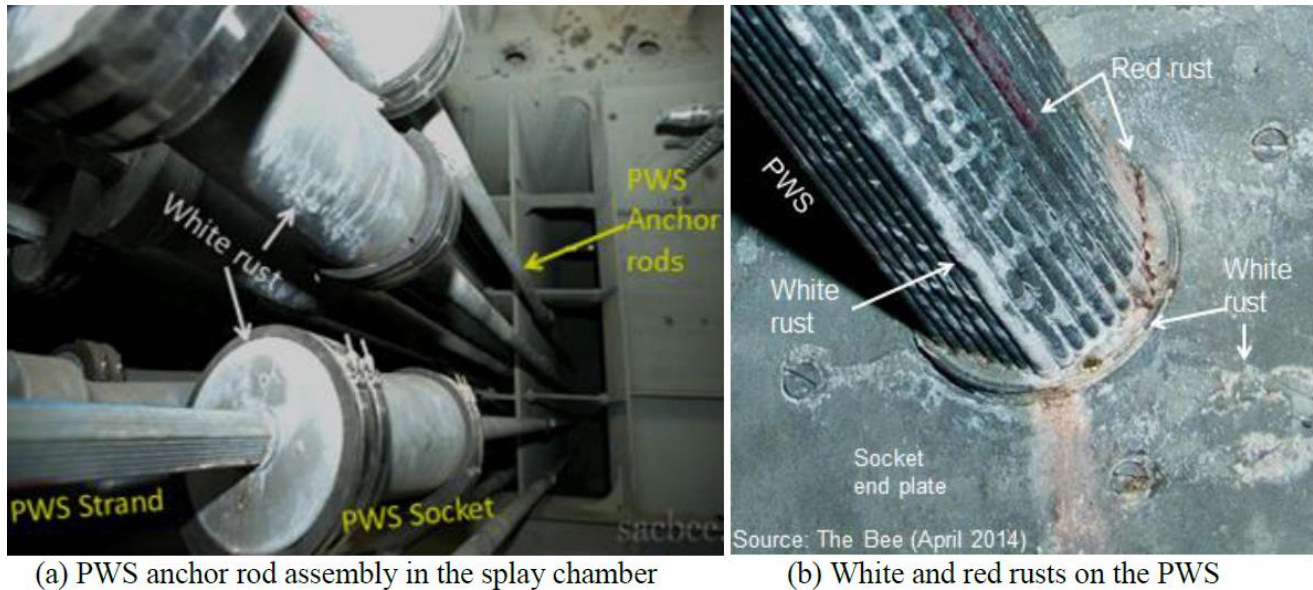
(b) White and red rusts on the PWS

Figure 12 Corrosion of PWS (parallel wire strand) assemblies in the SFOBB-SAS splay chambers.

**A8.2** The PWS may fail due to corrosion fatigue cracking at the entry to the socket (Figure 12b).

the two splay chambers. The dehumidification systems for the cable were completed as of May 2014.<sup>55</sup> It is recommended that Caltrans consider the use of a vapor phase corrosion inhibitor in the splay chambers and saddles to slow down or arrest any corrosion of the steel wires. The corrosion of the PWS at the entry point into the socket has a more serious problem: corrosion fatigue cracking failures of the wires.

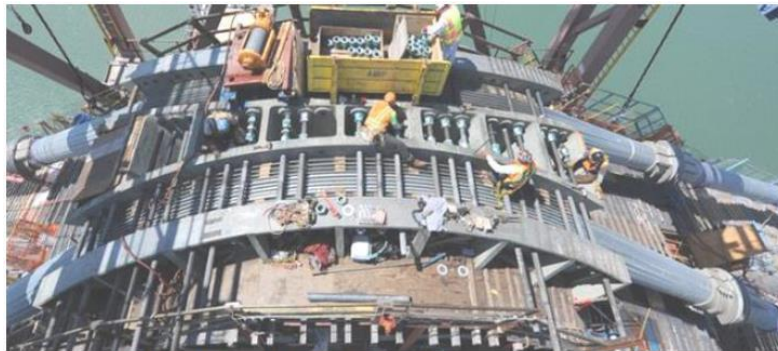
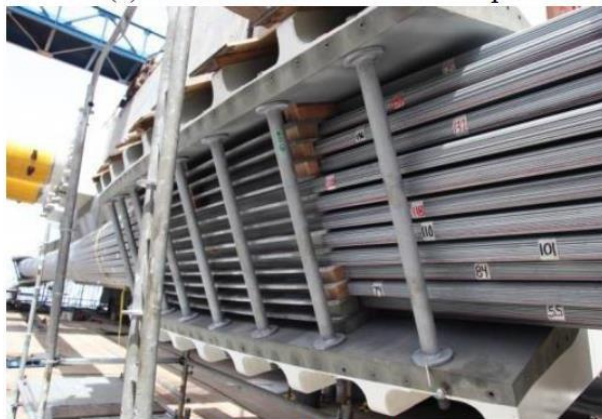
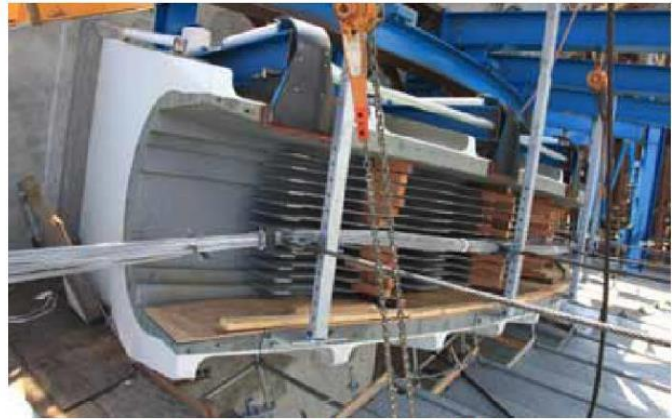
Figure 13

Exposed PWS (parallel wire strands) across the saddles. (a) and (b) after complete placement of 137 PWS. (c) one of the two deviation saddles at Pier W2 after the first PWS passed over.

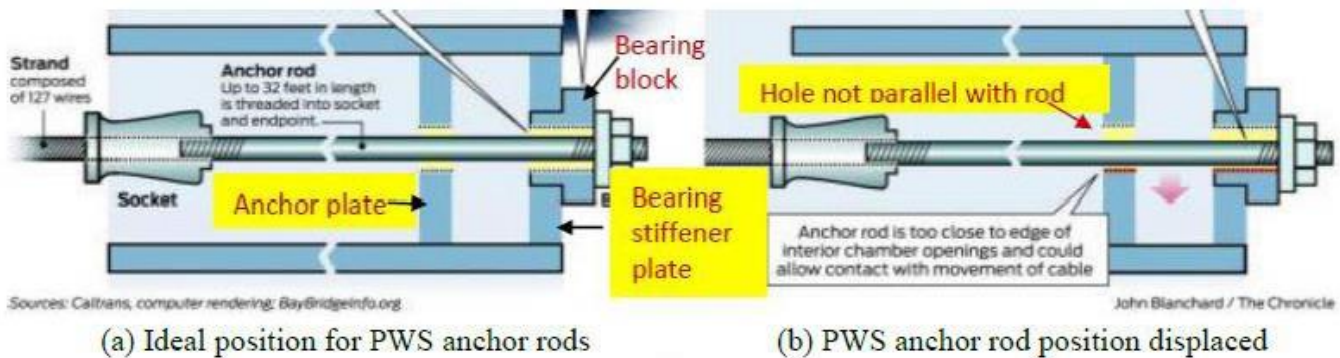
The PWS anchor rods shown in Figure 14 are supposed to have a 10 mm annular clearance in the round holes of the anchor plate shown in Figure 15a.<sup>56</sup> Caltrans found in May 2014 that many of them had slid downward, leaving less than a 10 mm clearance as illustrated in Figure 15b.<sup>57</sup> Since the PWS anchor rods slope downward vertically, the lack of clearance could cause a pinch or rubbing in the anchor rods against the sharp edges of the holes in the anchor plate (Figure 16).

Figure 15 Illustration of PWS anchor rod position displacements in the anchor wall in the splay chamber.

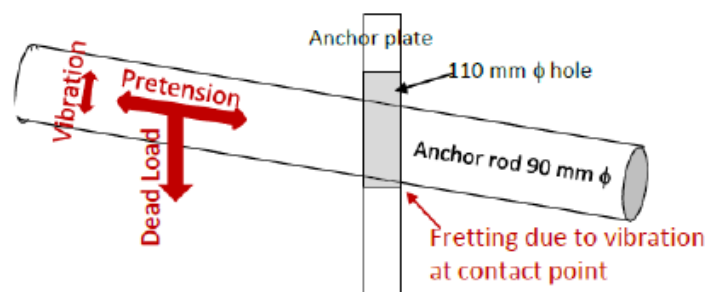
Caltrans did not clarify if the PWS anchor rods were off-centered when installed or they became off-centered after the SAS span was opened to traffic in September 2013. It is probable that they became off-centered due to nut vibration loosening, as illustrated in Figure 16. This is a common problem in threaded connections, particularly with low pretension levels ( $0.35F_u$ ). All steel bridge decks vibrate due to wind and traffic loading.

Fig. 16 Vibration as a cause of the BD rod displacements

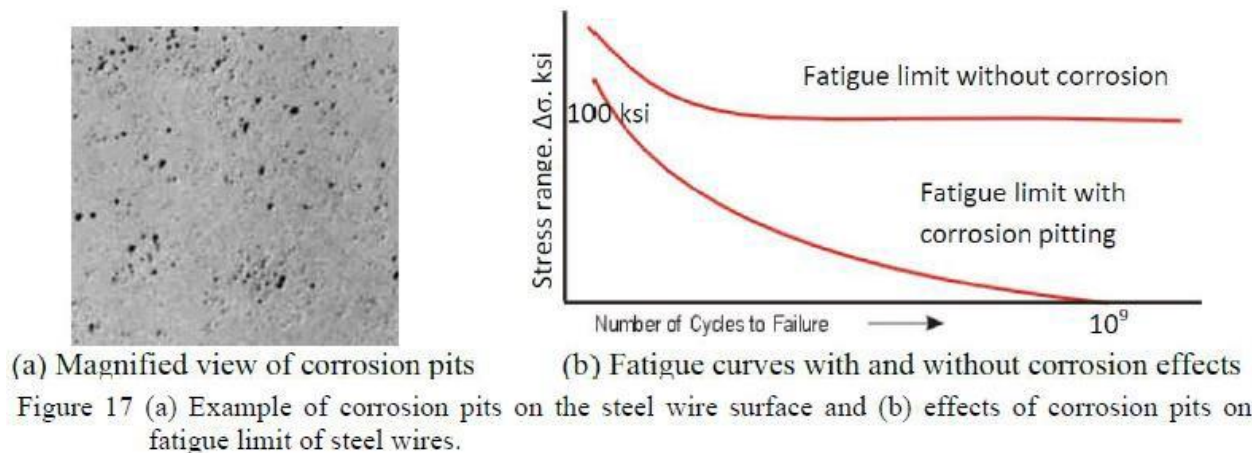
It is well known, however, that corrosion pits such as those in Figure 17a would lower the fatigue strength as illustrated in Figure 17b. The fatigue strength of the steel wire would continue to decrease if damaged progressively by corrosion. This would indicate the strand-socket junctures can fail due to corrosion fatigue unless the steel wire corrosion is stopped now.

The only effective means of preventing the strand-socket junctures from failing due to corrosion fatigue is to protect the strand-socket-anchor rods from corroding now. This can be most effectively done by maintaining the air around them as dry. This must be the primary reason that the splay chambers were required to be dehumidified to maintain the relative humidity (RH) to 40% or lower. This is most essential for the SAS span to last the 150-year design life. The cable strands, sockets, and anchor rods in the splay chambers have formed white and red rusts, however, only because Caltrans has

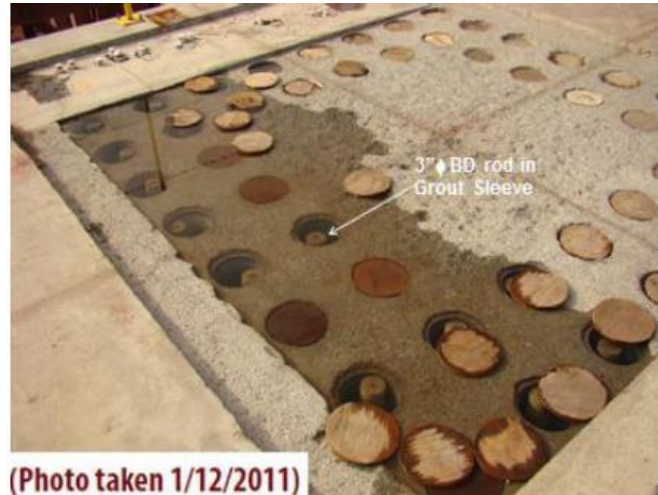
of the grout sleeves (7 in pipe) had unsecured plywood discs as covers (Figure 20).

Fig. 20 Rainwater filled grout sleeves in Pier E2

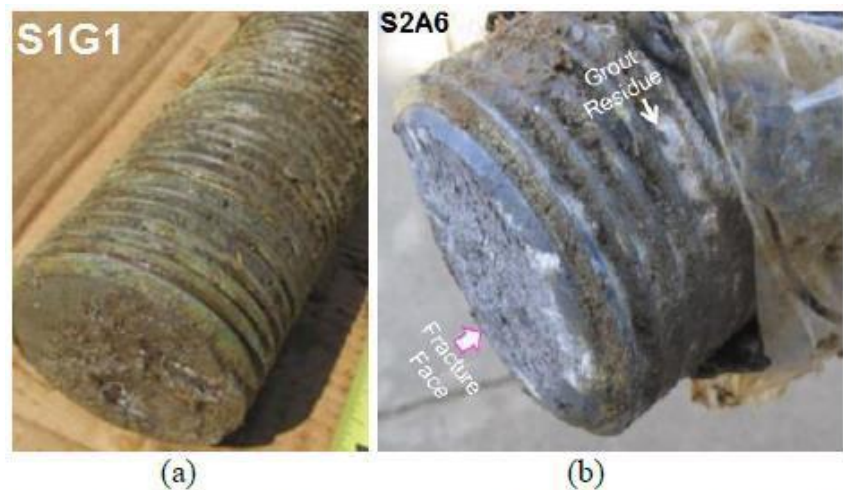
Fig. 21 Examples of failed shear key BD rods, S1G1 and S2A6.
