# Materials Performance Anchor Rod Questions and Responses

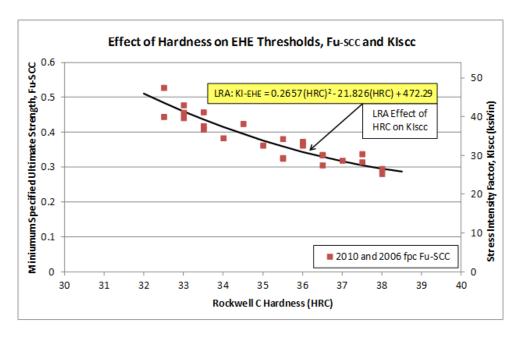
As also described in Reference 1.1, the stresses and equivalent loads at which samples of the rod materials cracked due to HE were also measured in Test V using small Charpy size specimens. The Test V results corroborated the Test IV results. In addition, since many more specimens were tested in Test V, they permitted correlations to be developed for several sets of the rods between hardness and the stress required for occurrence of HE. These correlations showed that the stress required for occurrence of HE decreased as hardness increased, and that it also decreased as the potential established by the zinc coating became more negative, as shown in the two figures below.

Effect of hardness on EHE threshold force ultimate and stress intensity factor (Ref. 1.2) (Note that this figure is for specimens with fatigue precracks, i.e., for KIscc; the threshold for specimens with thread roots, i.e., KIρ, was about twice as high.)

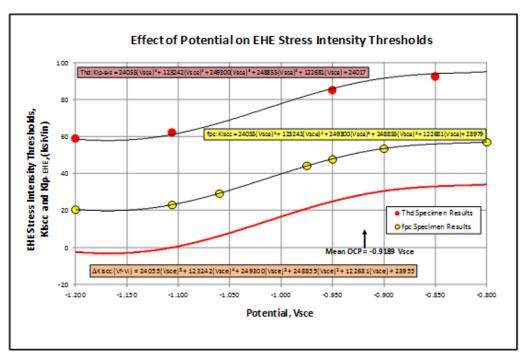
Effect of OCP on the measured KIscc and KIp-EHE (Ref. 1.2)

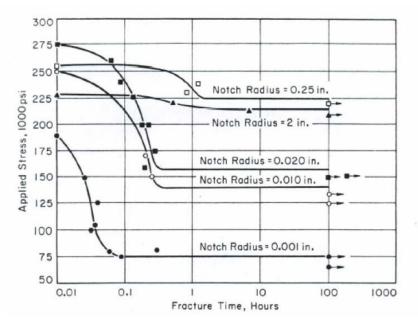
It is also expected that the applied stress required to cause HE will decrease as the stress concentration at the thread root becomes higher. This type of effect has been thoroughly explored as described in Reference 1.2 and shown in the figure below, which presents results of susceptibility to HE as a function of notch root radius. Since the conditions at the root of threads can vary among groups of rods, and between rods in a group, this is another source of variability in the threshold stress for occurrence of HE.

Effect of Notch Root Radius on Delayed Failure Processes in a High-Strength Steel (from Reference 1.3)

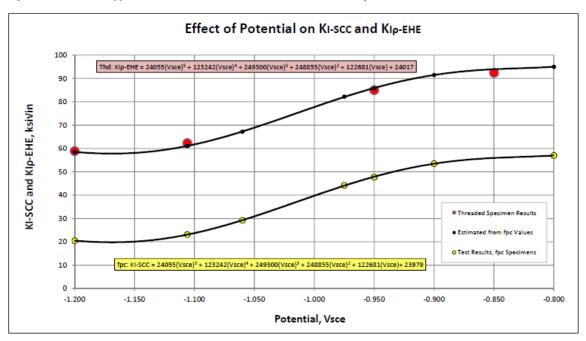
Figure 3.2-12: Effect of Applied Polarization Potential on the Measured KIscc and KIρ-EHE

• If microcracks are present at the root of the threads in a highly stressed area, such as at the first engaged thread at the lower nut, this could potentially reduce the load required to cause HE by about a factor of two. The basis for this hypothesis is that the presence of a continuous string of microcracks at the root of the thread would make the thread similar from a fracture mechanics standpoint to a fatigue sharpened fatigue crack. As shown by the following figure from Reference 7.1, a sharp pre-crack reduces the load for HE by about a factor of two.
