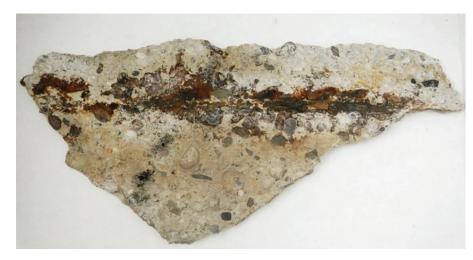
FIGURE 5 Close-up photograph of the rebar inside core sample with thickness loss shown at the top. The corrosion risk was captured early on. Corrosion mitigation and cathodic protection prevented catastrophic failure in a 100-year-old building.

Figure 5 is a close-up photograph of the rebar inside core sample with thickness loss shown at the top. The corrosion risk was captured early on. Corrosion mitigation and cathodic protection prevented catastrophic failure in this 100-year-old building.
