## *Materials Performance Anchor Rod Questions and Responses*

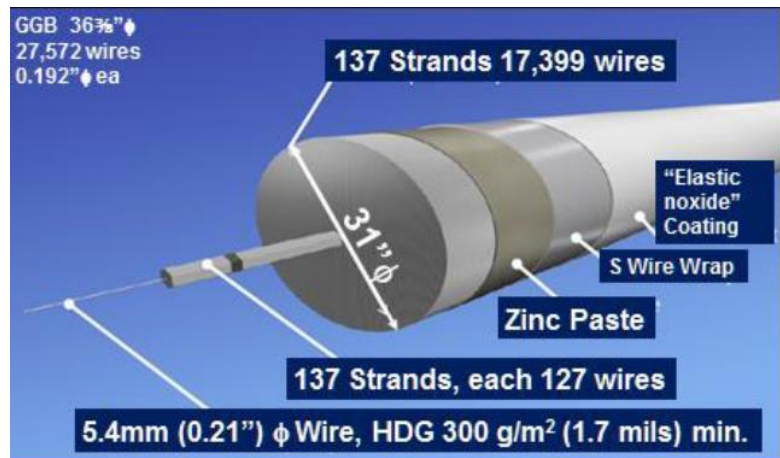
Figure 11 SFOBB-SAS main suspension cable

**A8.1** The weakest link that will determine the life of the SFOBB SAS span is not the Grade BD anchor rods or the fatigue cracking of orthotropic steel traffic decks; it is the main suspension cable. This is because Caltrans has neglected to protect the main cable from corroding where its individual steel wires are exposed to the moist marine air in the splay chambers, east of Pier E2, and probably also in the tower cable saddle at T1, and in the two deviation saddles and one jacking saddle at Pier W2. At these six locations, the individual steel wires of the suspension cable are fully exposed to the surrounding air. The BD anchor rods may fail due to EHE; they can be replaced with more EHE resistant rods without closing the bridge. The single, continuous suspension cable for the SFOBB-SAS span cannot be replaced without first building a support bridge underneath it and closing the bridge for traffic for a long time. The suspension cable can fail due to corrosion, corrosion fatigue, or both.

This main cable is made of over 17,000 steel wires in 137 strands (Figure 11). Each wire has an HDG zinc coating with a minimum specified thickness of 1.7 mils. It would provide only about a 20 year life in open atmospheric service according to Figure 6.

As shown in Figure 11, the suspension cable is protected from atmospheric corrosion by using zinc paste, S-wire wrap, and “elastic noxide” coating. In the following six locations, however, the individual strands have no corrosion protection except that the air in the chamber is supposed to have been dehumidified (to lower than 40% relative humidity) for corrosion protection of the wires.

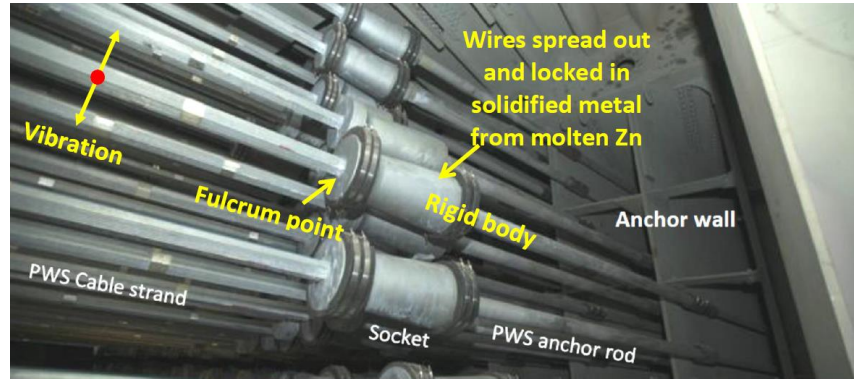
Figure 14 PWS anchor rod assemblies in the splay chamber.

The PWS anchor rods shown in Figure 14 are supposed to have a 10 mm annular clearance in the round holes of the anchor plate shown in Figure 15a.<sup>56</sup> Caltrans found in May 2014 that many of them had slid downward, leaving less than a 10 mm clearance as illustrated in Figure 15b.<sup>57</sup> Since the PWS anchor rods slope downward vertically, the lack of clearance could cause a pinch or rubbing in the anchor rods against the sharp edges of the holes in the anchor plate (Figure 16).

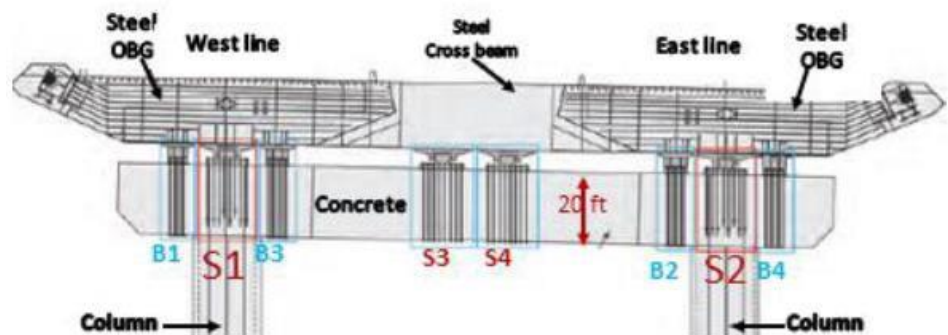
Fig. 18 Elevation drawing of Pier E2

The 96 BD rods for shear keys S1 and S2 had to be installed in the cap beam while it was being constructed in 2008 (Figure 18). These rods are located directly in line with the pier columns. The top ends of the 96 BD rods had to be flush with the top side of the cap beam. This required an extra room in the bottom of grout sleeves, referred to as the top hat (Figure 19). The top hat is a 30 in long piece of 8 in steel pipe in the bottom of each grout sleeve. Its purpose was to keep the BD rod in the lower position “temporarily.” The BD rods were supposed to be raised up, grouted, and pretensioned.

Because of construction delays, however, the 96 BD rods for S1 and S2 remained in the grout sleeves from 12/2008 to 1/2013. During this 4-plus years, the 96 BD rods sat idly in the top hats while the top ends in the top side of the cap beam were fully exposed to the weather. The top ends

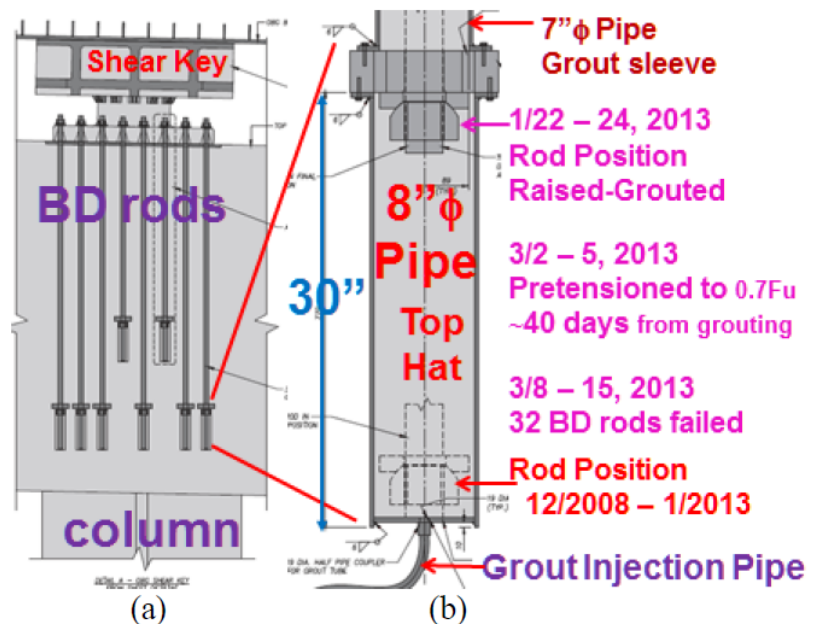
Fig. 19 Illustration of the top hat of the shear key rod sleeve

Caltrans has presented no data that can indicate how many more top hats had no water or can explain the reasons why S2A6 had no water. Originally, the sleeves were supposed to have been grouted from the bottom up using the grout injection pipe (19 mm PVC pipe) in the bottom of the top hat (Figure 19b).<sup>64</sup> The PVC grout injection pipes were supposed to have been routed to the bottom side of the cap beam. During its construction, however, they were routed to the top side of the cap beam, thus eliminating their drainage function. Whether or not some of the grout injection pipes were still routed to the cap beam bottom side as designed is unknown. Actually, the grout sleeves for the S1 and S2 anchor rods had to have been filled with grout by pouring it into the open top ends shown in Figure 19. This is the only way to have retained water in the grout sleeve bottom ends after the grouting.

Gorman et al believe that most corrosion of the zinc coating that provided the hydrogen for EHE occurred when the water in the top hat in the grout sleeve bottom ends in Figure 19 became caustic (from grout bleed) and that the corrosion rates of zinc in near-neutral water, like rainwater, are so low that hydrogen uptake during the 4-plus years prior to the grouting may be negligible. They may be incorrect, however, as the corrosion rates in rainwater and other natural waters can vary over a wide range (10 - 60  $\mu\text{m}/\text{year}$  or 0.4 - 2.4 mils/year).<sup>65</sup>

The S1 and S2 BD rods were under tension while simultaneously immersed in water for only 3 to 6 days (Figure 19), not long enough time for zinc/steel to corrode, generate hydrogen, for it to diffuse into the BD rods to reach a hydrogen concentration higher than a threshold level, and cause HE cracking.
